Lower Iliuliuk River Restoration and Management Plan

Prepared for:
City of Unalaska

Prepared by:
PND Engineers, Inc.

February 2015

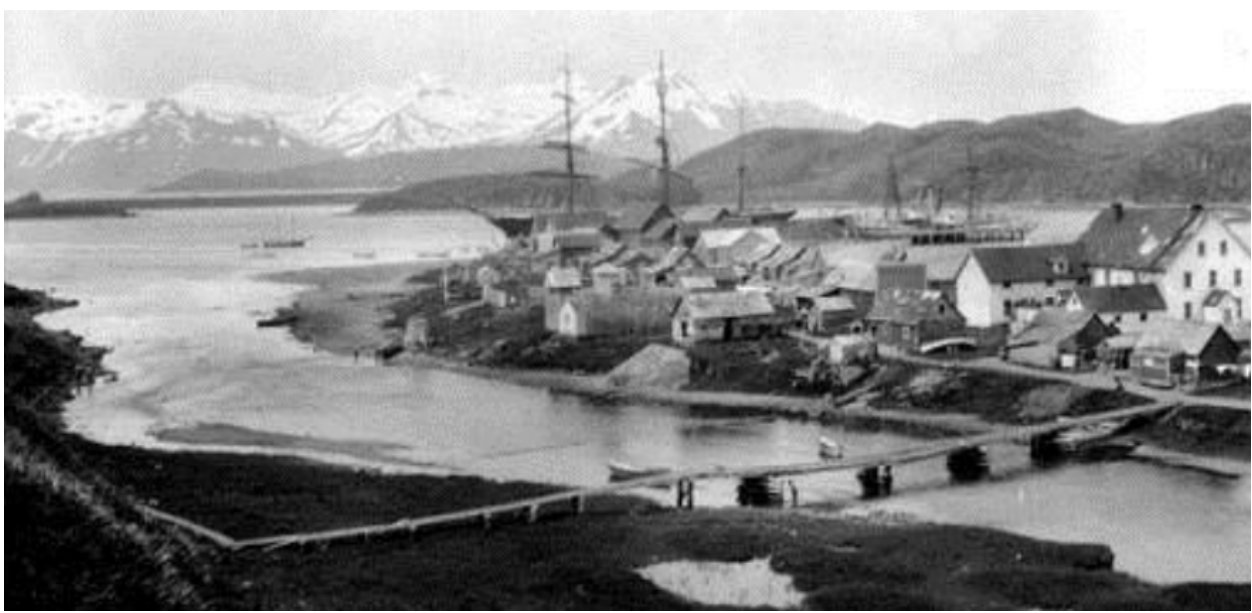
Photo 1-1. Historical Photo of the Mouth of the Iliuliuk River (courtesy of Jeff Hancock's public comment)

The north bank, within the project area, primarily consists of World War II road embankment. Road fill was observed underneath the vegetated mat. Based on historical photographs, it appears that vegetation has established on top of the gravel fill on its own. Photo 1-1 is a historical photo of the Iliuliuk River mouth prior to road construction, and filling of the north bank, and Photo 1-2 displays a photo taken in 2014 of the same area.

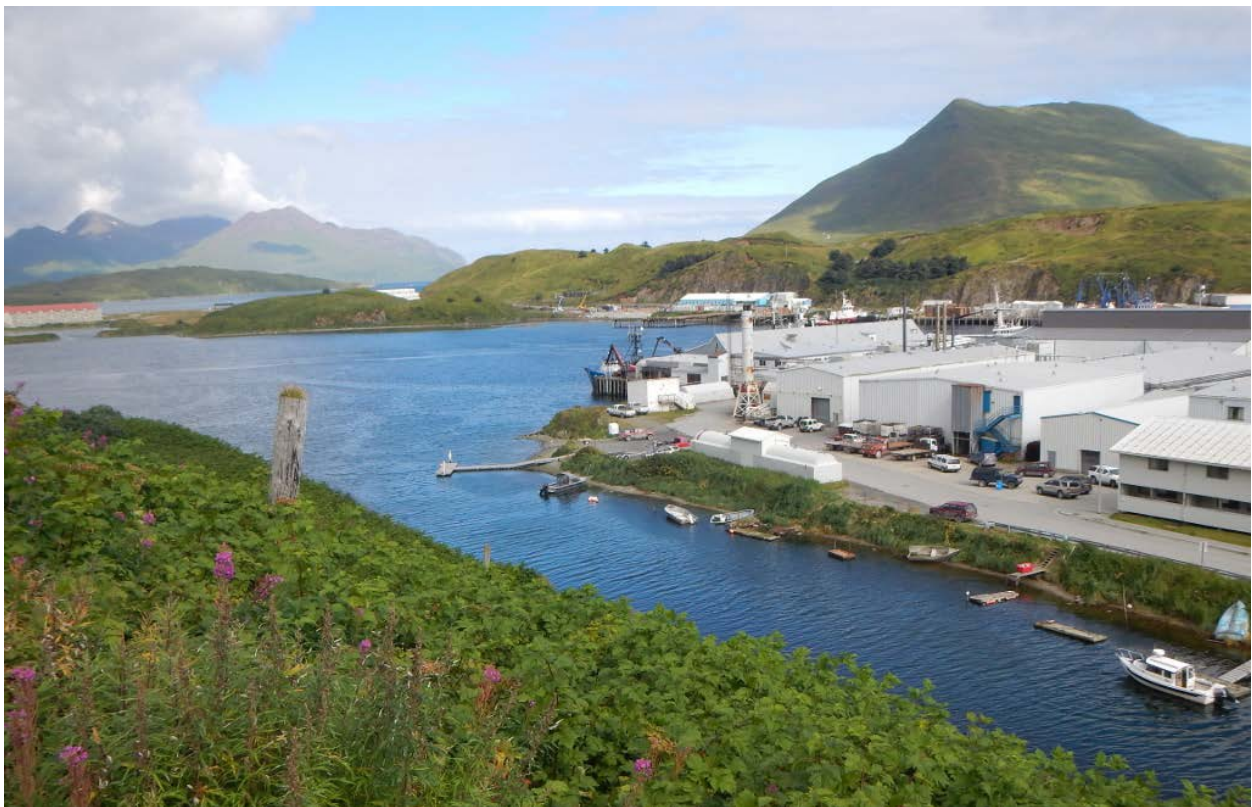
Photo 1-2. 2014 Photo of the Mouth of the Iliuliuk River

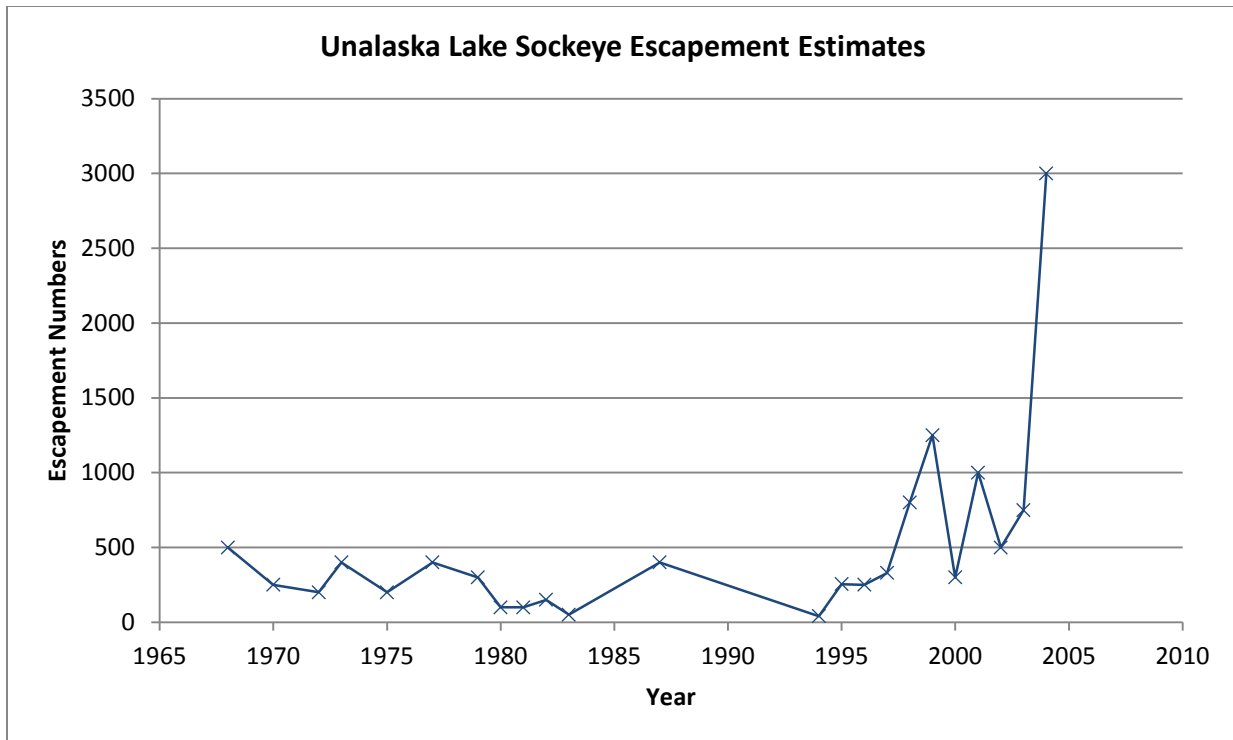
Figure 2-1. Unalaska Lake Sockeye Escapement Numbers (Tschersich 2007)

Unalaska Lake and Iliuliuk River watershed salmon populations are lower than anticipated by biologists. The pink salmon population is observed as being fairly healthy; however, the coho run could use some improvement, and the sockeye run appears to have declined significantly. According to the grant language funding this project, annual sockeye escapements have ranged from 100 to 400 since 1970 (State of Alaska 2011). Comparing Unalaska Lake to similar systems in this part of the state, Alaska Department of Fish and Game (ADF&G) fisheries biologists estimate that a lake of this size could have an escapement of at least 2,000 to 3,000 sockeye. Currently, no measures are being taken to gather return numbers of sockeye salmon back into the watershed; however, stream surveys (aerial and foot) have been conducted on Unalaska in the past. These surveys are conducted by enumerating a number of salmon present in the water body at the specific time. The total escapement estimate is based on peak counts and given an expansion factor based on species research and literature. It should be noted that “aerial and foot surveys for salmon often underestimate the true number of salmon by not enumerating the entire population over time” (Holmes 1997). These escapement counts, as presented in Tscherish’s 2007 report: Aleutian Islands and Atka-Amlia Islands Management Areas Salmon Management Report, 2006, are presented in Figure 2-1. According to Tschersich, “Unalaska Lake has not reached its minimum sockeye salmon peak count escapement objective of 400 fish in numerous years between 1987 and 2006). Siltation has occurred in this lake and its drainages since World War II”.

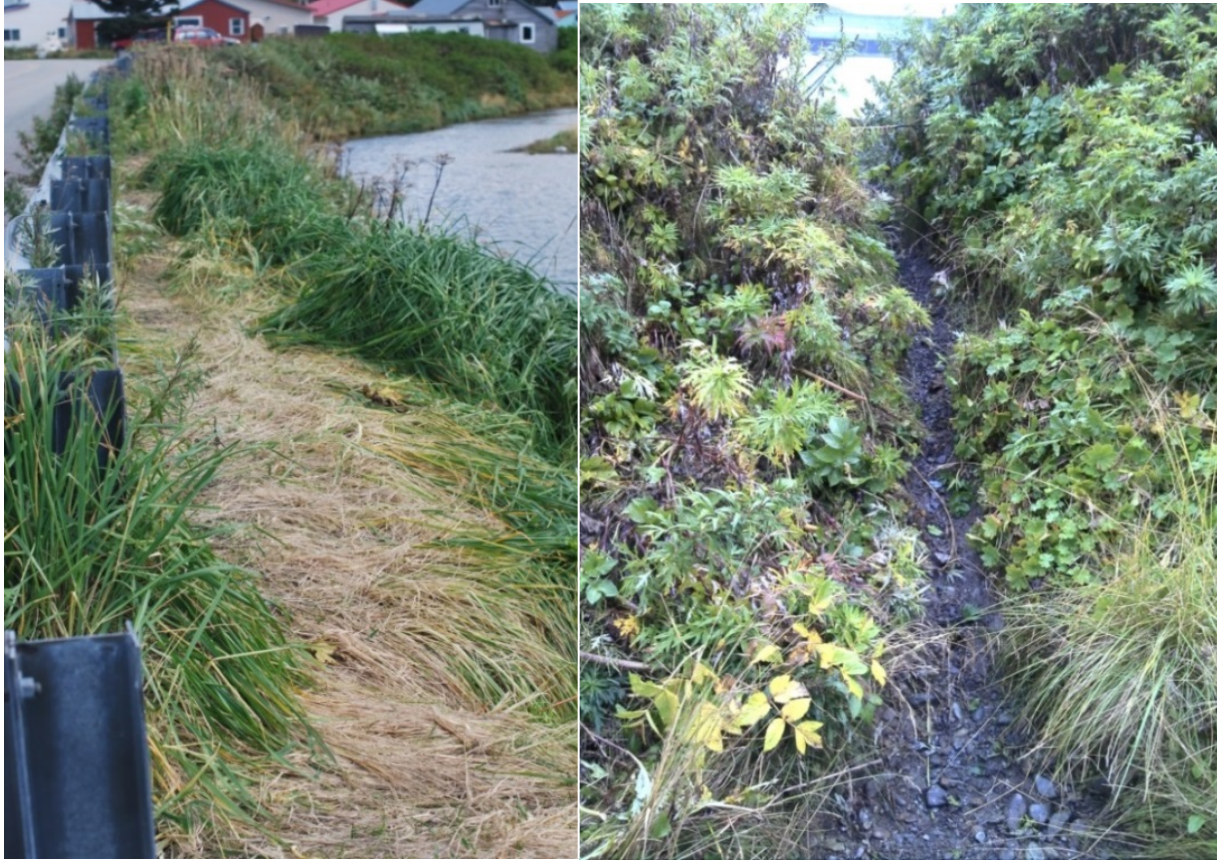
Photo 2-2. Left: Trampled Vegetation along Guardrail; Right: Noted Erosion on Upper Riverbank due to Surface Drainage

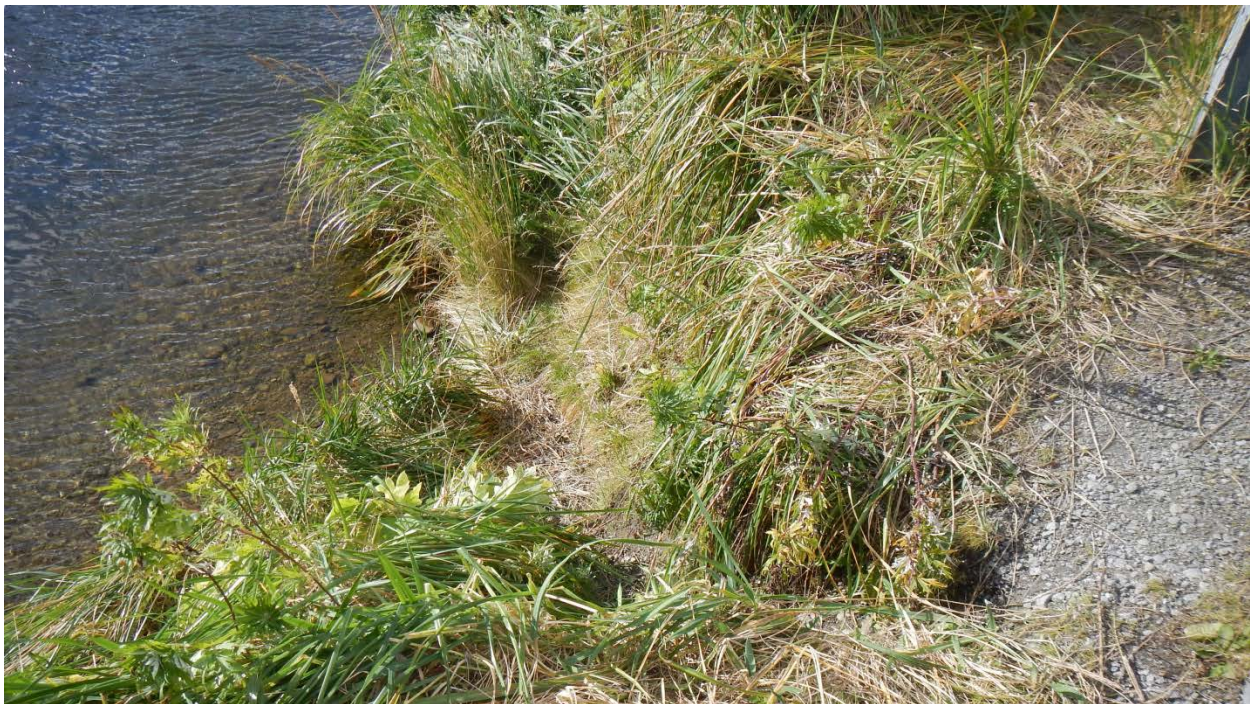
Photo 2-3. Noted Erosion along the Banks of the Lower Iliuliuk River due to Foot Traffic

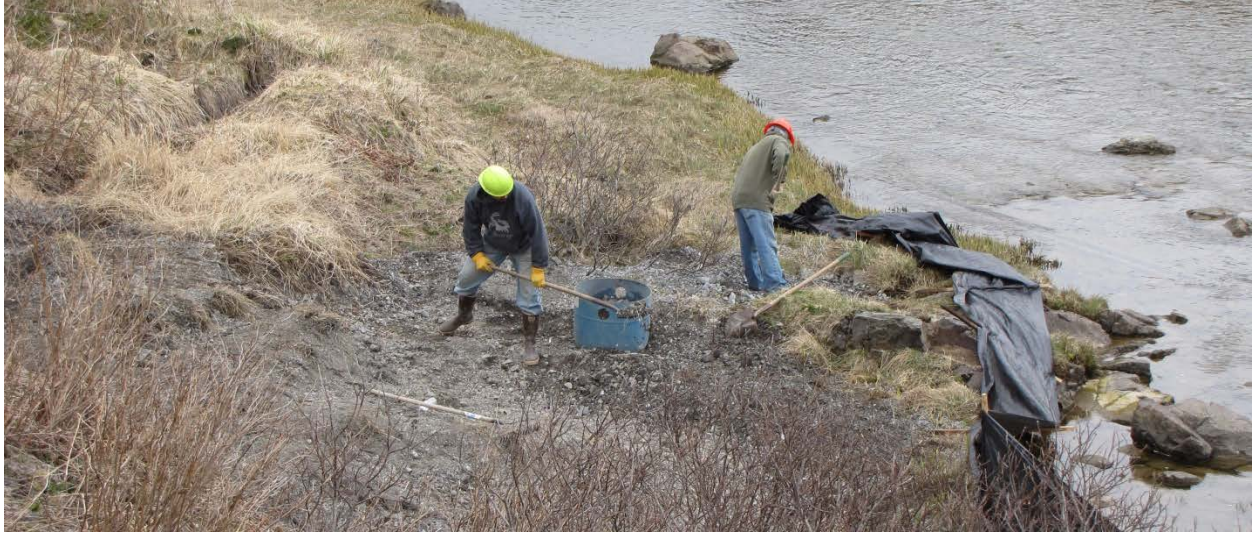
Photo 2-5. City Roads Crews Cleaning up Snow Dump along South Bank of the River

into the river. Snow piles that accumulate throughout the winter along the river can contain large amounts of gravel and other potential pollutants that will drain into the river each spring. Photo 2-5 displays the City Roads crew cleaning up a snow dump on the south side of the Iliuliuk River.

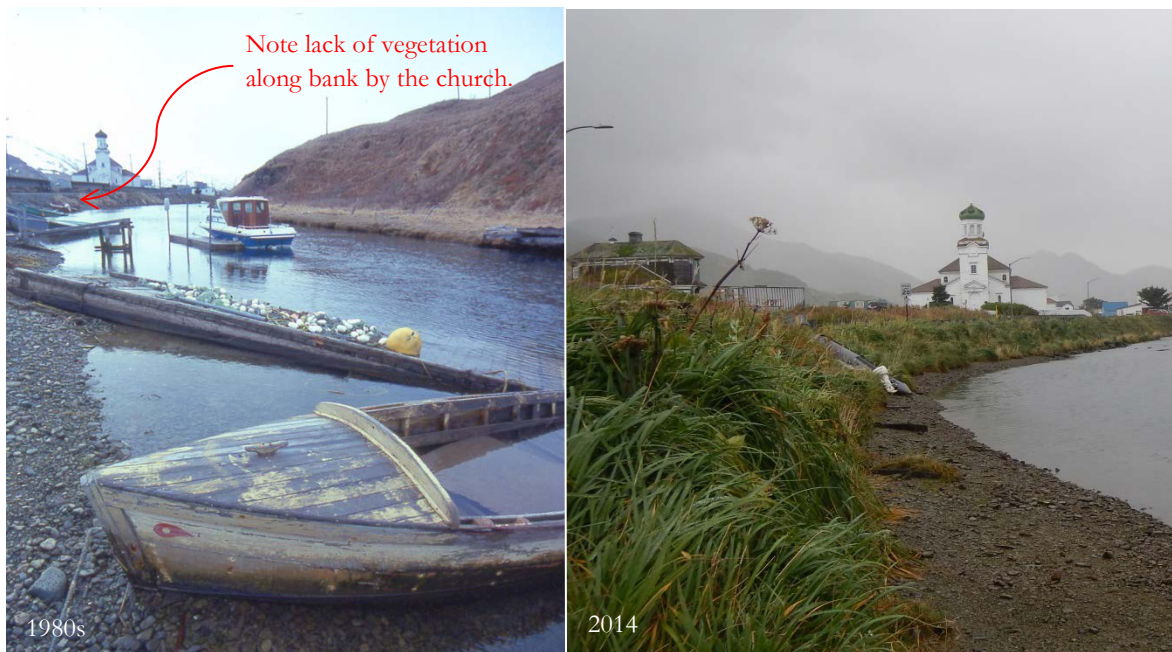
Photo 3-1. Left: Bank Photo from 1980s; Right: Bank Photo from 2014

As noted in the attached wetlands delineation report, the majority of vegetation along the north bank of the lower river consisted of beach wildrye, and soil generally consisted of gravel road fill. Over time, vegetation has naturally started taking hold of the bank. Community member comment and historical photography supports this conclusion. As recently as the 1980s, very little area on the banks had healthy growing beach wildrye. The site visit in 2014 displayed a much wider area of vegetation with some wetland areas. See Photo 3-1.

This suggests that the hardy beach wildrye grass will eventually begin to take hold on its own. Revegetating areas with lack of grass will speed up this process, and in turn, immediately provide some protection in areas that are eroding.

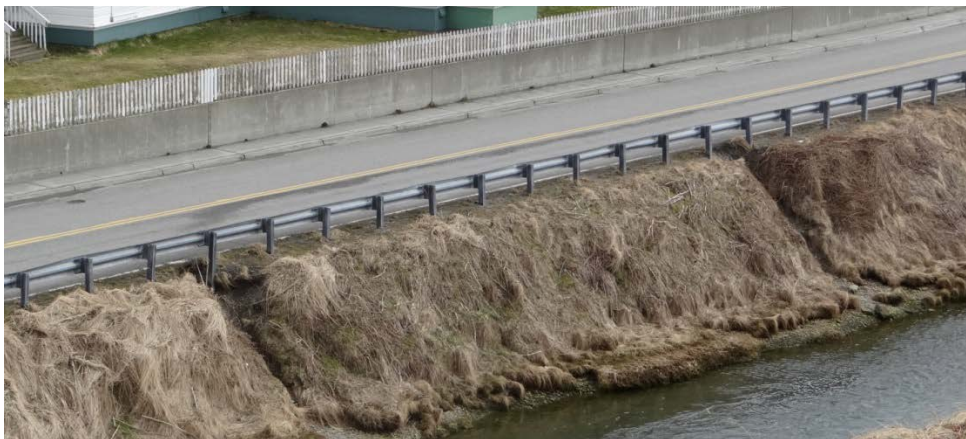
Photo 3-2. Erosion from Runoff Threatening Roadway

Additional erosion prevention, not addressed in the grant, would require addressing drainage issues from the north and south sides of West Broadway Avenue. Several areas of erosion are threatening the road. During rain events, surface water drains over West Broadway Avenue's pavement and finds the lowest spot along the north bank. In some locations, the erosion is abutted or even has undermined the existing pavement structure. Some of these areas of notable erosion due to uncontrolled runoff are displayed in Photo 3-1(right) and Photo 3-2. An option for addressing this issue could include placement of riprap on top of the current eroded area. This would slow down runoff and protect the underlying soil from future erosion. Revegetation of beach wildrye could be incorporated into these areas as well.

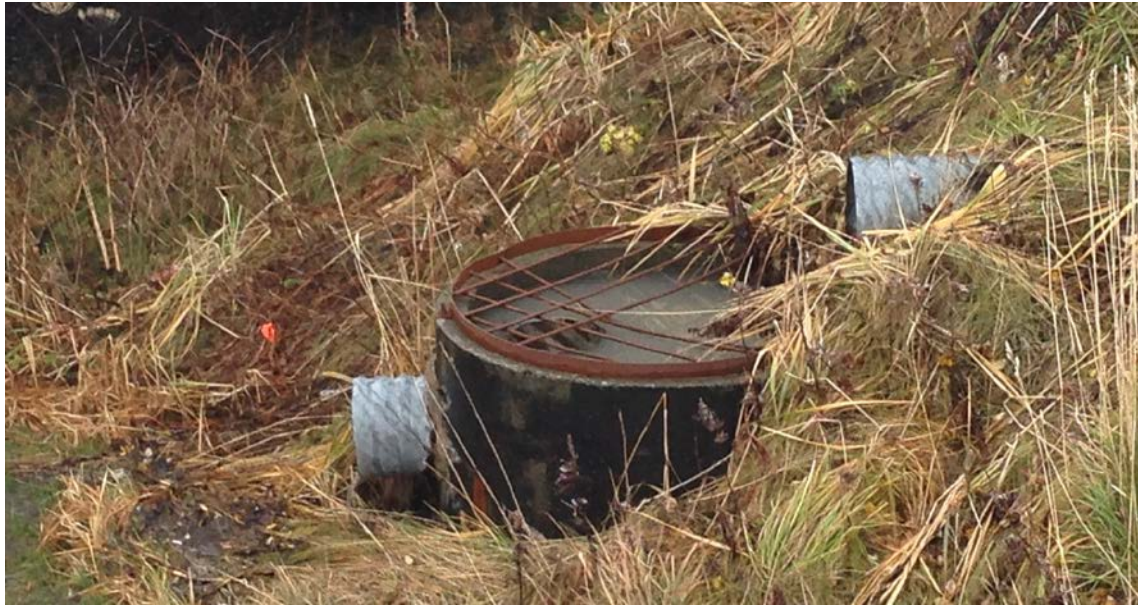
Photo 3-3. Outfall Sediment Collection System near 5th St. Bridge

The lower river is also subject to sedimentation. Storm drains can capture sediment throughout their runoff path and discharge the sediment into the lower river at an outfall. A settleable solid collection system at the outlet of the storm drain system could help collect the sediment, reduce stream bank erosion, and allow for easier maintenance and cleanout of the system where workers could flush out the storm drain without discharging directly into the river. This could be accomplished through installation of precast concrete barrel sections at the outlet of multiple culverts along the lower river. One of these structures is in place adjacent to the 5th Street Bridge as shown in Photo 3-3.

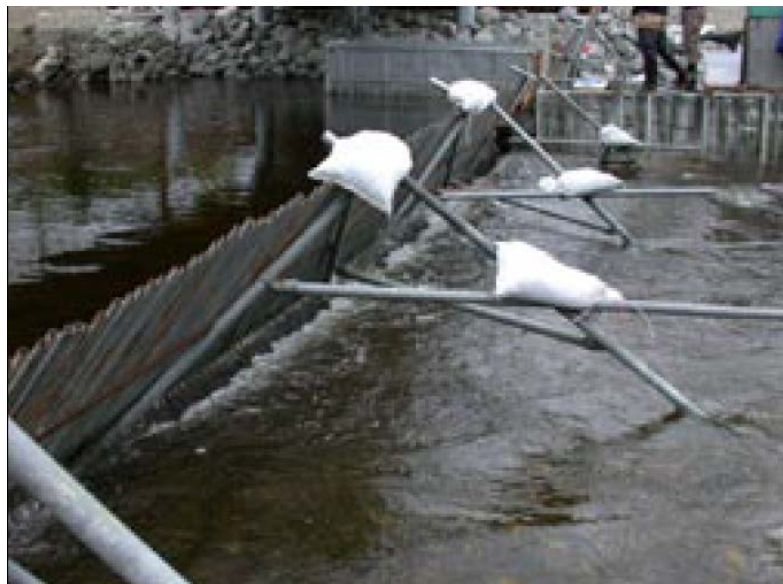
Photo 3-4. Rigid Tripod Weir Example (Zimmerman & Zabkar)

A rigid weir, or tripod weir, would be installed across the river, and semi-fixed to the stream. These weirs can be constructed out of varying materials, such as PVC pipe or aluminum pickets, screen or wire panels, and netting. Pickets are strung together and angled at 120 degrees from the streambed to allow pressure dissipation from the water, and are held in place by tripods constructed of pipe, such as electrical conduit. See Photo 3-3. These rigid weirs require a somewhat steady water surface elevation in order to work properly.

The rigid weir is removable, and can require a significant amount of maintenance. The rigid pickets across the stream tend to pick up debris, leaves, and algae, which clog the weir from water movement. This can create an elevated amount of pressure behind the weir leading to blow out. The panels need to be cleaned often. Additionally, during storm events, or high water, the entire weir can become damaged and carried downstream.

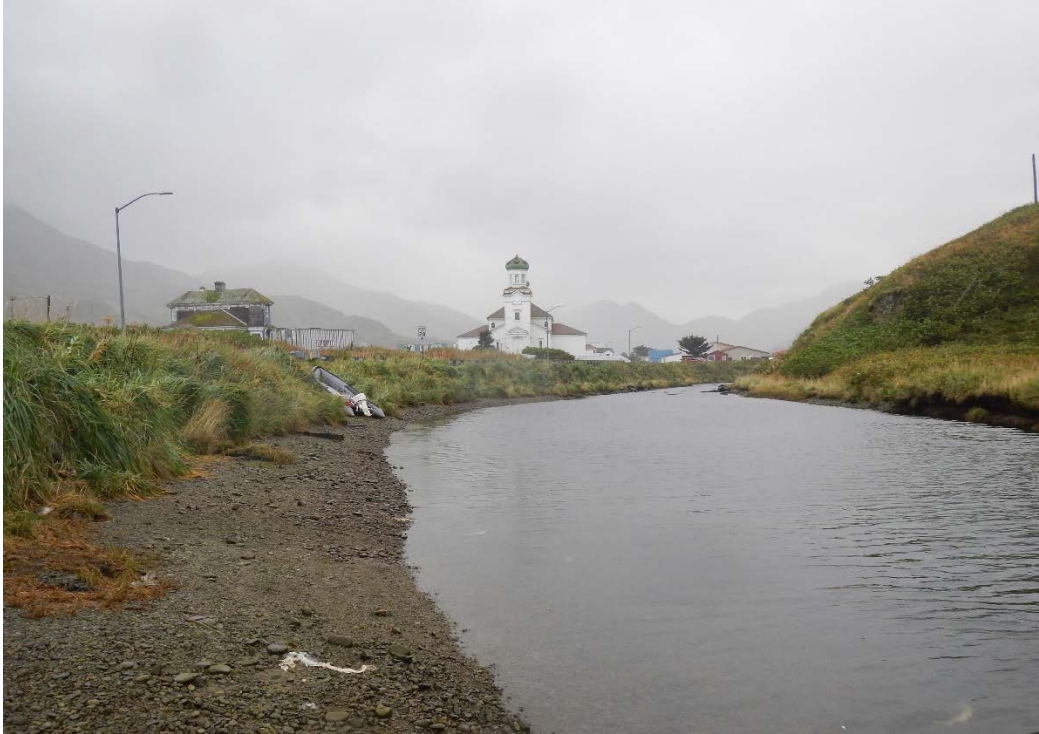
Picture 4. River at low tide.

The lower Iliuliuk River within the project area was determined to be a tidal riverine wetland due to the tidal influences from Iliuliuk Bay on the river. During low tide periods, the rocky streambed could be seen along the river's edge. The streambed that remained underwater was assumed to include patchy cobbles due to the streambed conditions 50-100 feet upstream of the project boundaries. There were few wetland plants in this portion of the project area and the site was assumed to be wetland although wetland plants were not fully assessed.
